Re: **Administrative Docket No. CWA-02-2016-3036**
GMD Shipyard Corp., SPDES Tracking No. NYR00D162
Clean Water Act Administrative Compliance Order

**ADMINISTRATIVE
COMPLIANCE ORDER**

CWA-02-2016-3036

Compliance Evaluation Inspection: GMD Shipyard Corp.	
Inspection Date: February 26, 2016	EPA Inspector: Kimberly McEathron, Physical Scientist, USEPA Region 2, (212) 637-4228
Inspection Time: 9:45 AM – 11:30 AM	
On-Site Representative: Kevin Nugent, Director of Health, Safety and Environment, GMD Shipyard Corp., (718) 260-9200	
Site Information:	Lat / Long: 40.700, -73.969 GMD Shipyard Corp. Brooklyn Navy Yard BLDG. 595 63 Flushing Avenue Unit #278 Brooklyn, NY 11205 SPDES/ICIS No. NYR00D162
SIC Code:	3731 – Ship Building and Repairing

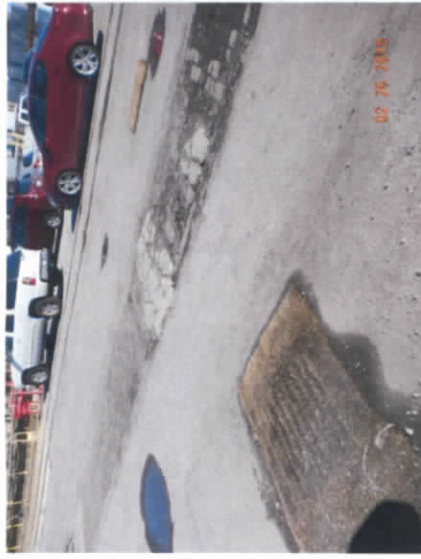
DSCN6635

At the time of the inspection, EPA inspector McEathron observed at least three (3) stormwater drainage structures on Berth 9 covered with fabric covering the drain (see photographs DSCN6635.JPG – DSCN6636.JPG and DSCN6648.JPG). According to the Facility representative, the storm drains were covered with the fabric after they had been cleaned out. At the time of the inspection, EPA inspector McEathron observed a catch basin filled with debris on Berth 9 (see photograph DSCN6646.JPG). According to the Facility representative, portions of the stormwater drainage system on Site have not been completely cleaned out because the debris in the structures is too hard to break through and additional tools are necessary.

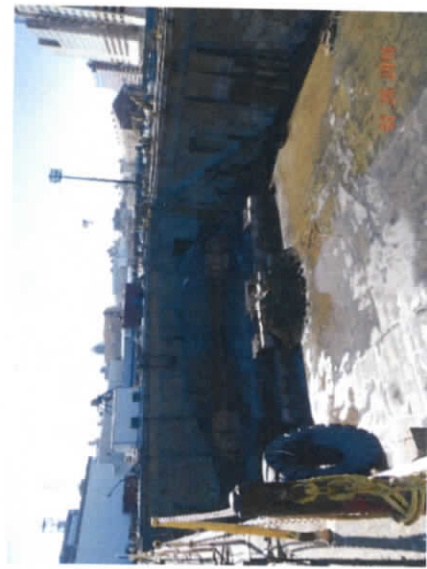
DSCN6642

1. A large pile of spent grit, soil, sediment, trash and other materials in the southeast end of Dry Dock 5 (see photographs DSCN6642.JPG and DSCN6657.JPG – DSCN6658.JPG). According to the Facility representative, this pile has been at this location for over fifteen (15) years. Therefore, the material has not been removed when the dry dock is flooded and the material is completely submerged with water. This pile appeared to be only slightly smaller than when EPA first observed the pile at the time of the May 14, 2014 CEI.

- i. A large pile of spent grit, soil, sediment, trash and other materials in the southeast end of Dry Dock 5 (see photographs DSCN6642.JPG and DSCN6657.JPG – DSCN6658.JPG). According to the Facility representative, this pile has been at this location for over fifteen (15) years. Therefore, the material has not been removed when the dry dock is flooded and the material is completely submerged with water. This pile appeared to be only slightly smaller than when EPA first observed the pile at the time of the May 14, 2014 CEI;

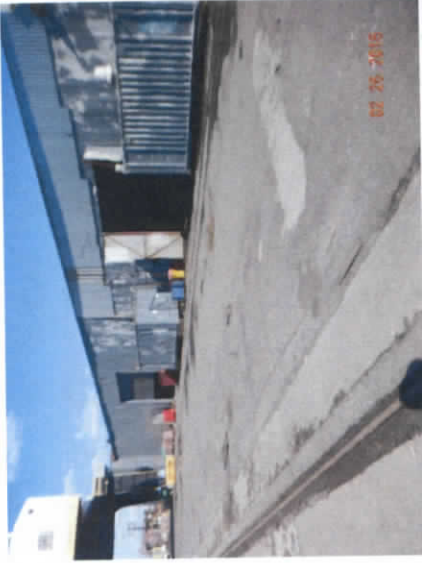
DSCN6644

4. At the time of the inspection, EPA inspector McEathron observed at least three (3) catch basins where the fabric was out of place or removed at the time of the inspection (see photographs DSCN6637.JPG – DSCN6638.JPG, DSCN6644.JPG and DSCN6684.JPG – DSCN6687.JPG).

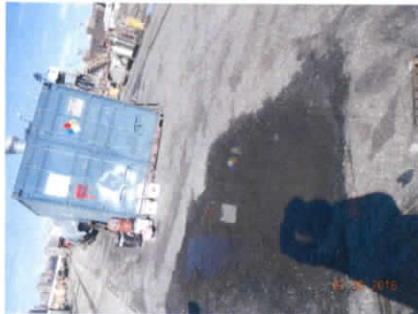
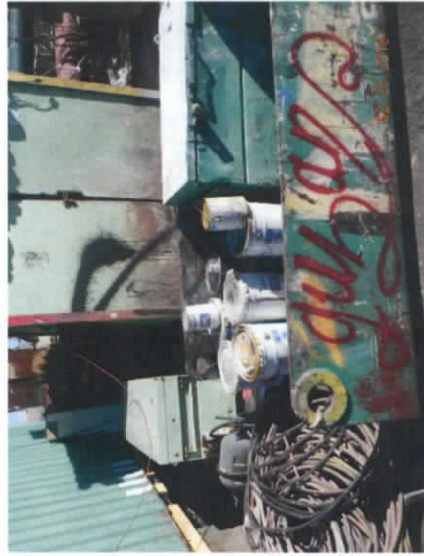
At the time of the inspection, EPA inspector McEathron observed a spill kit on-site on Berth 9 (see photograph DSCN6692.JPG). At the time of the inspection, EPA inspector McEathron observed used paint containers outside, exposed to stormwater and without containment at two (2) locations on Berth 9 uphill from catch basins (see photographs DSCN6665.JPG and DSCN6669.JPG).

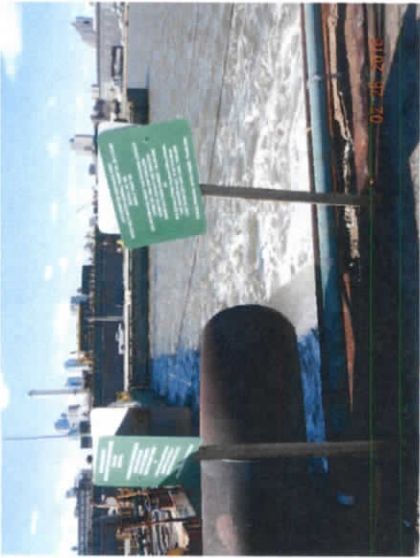
DSCN66671

At the time of the inspection, EPA inspector McEathron observed discharges from Stripping/Sump Pumps at Outfall 005 to the East River (see photographs DSCN6671.JPG – DSCN6673.JPG).

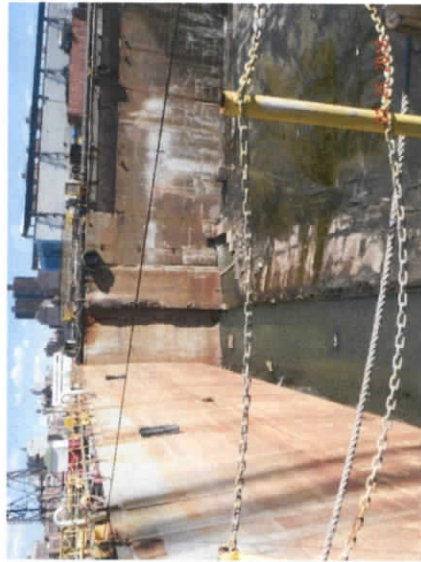
DSCN66675

At the time of the inspection, EPA inspector McEathron observed water entering Dry Docks 5 and 6 from the East River through leaks in the respective caisson gates, groundwater infiltration and leaks from the pumping room and potable water sources (see photographs DSCN6652.JPG and DSCN6675.JPG).

DSCN6674.JPG	Outfall 006 outfall sign
DSCN6675.JPG	Along caisson door, water flowing in from across the dry dock from apparent leak
DSCN6676.JPG	1 new small pump and 2 large submersible pumps on north side of dry dock No. 5

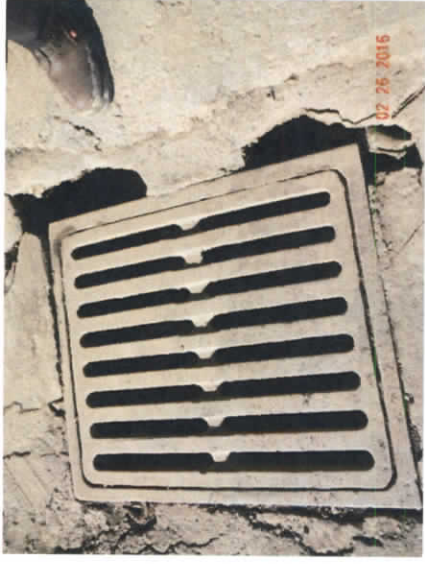
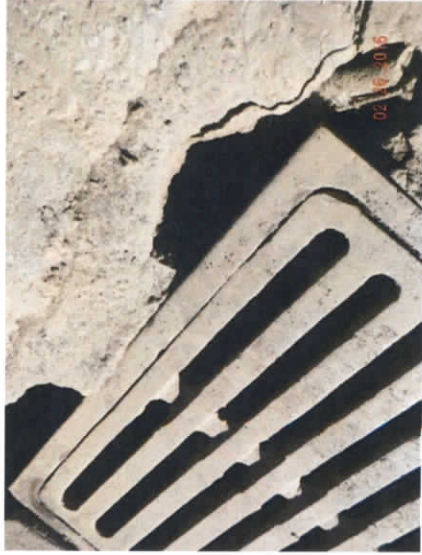
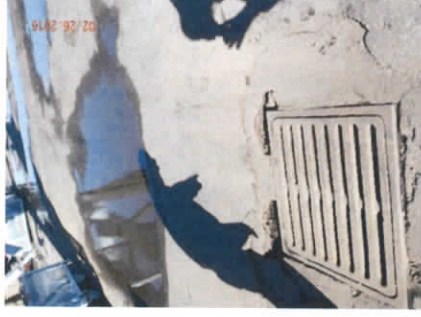
1. At the time of the inspection, EPA inspector McEathron observed a catch basin on Berth 8 with a broken frame where the catch basin lid was almost entirely unsupported on one side (see photographs DSCN6681.JPG – DSCN6683.JPG);

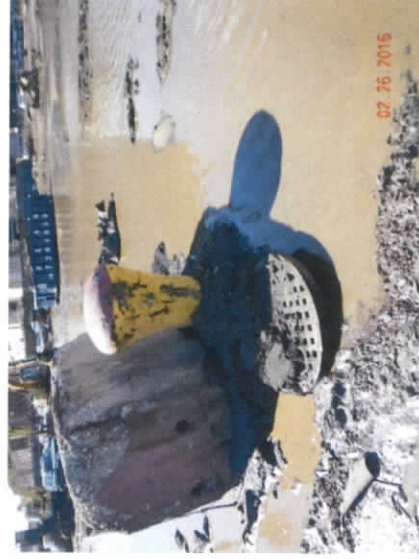
DSCN6691

2. At the time of the inspection, EPA inspector McEathron observed a grated manhole lid at this location (see photograph DSCN6691.JPG). At the time of the inspection, the Facility representative was unsure where the manhole lid came from and was unsure of the location of the catch basins in this area;

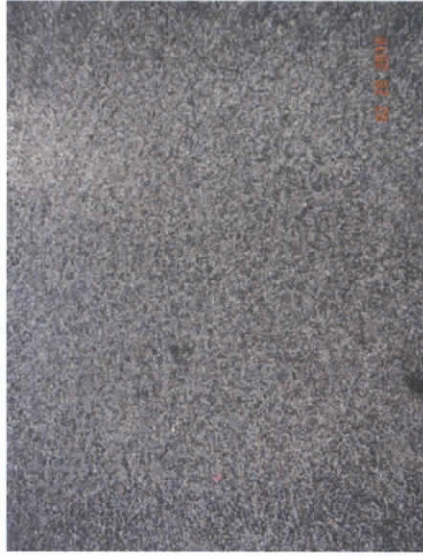
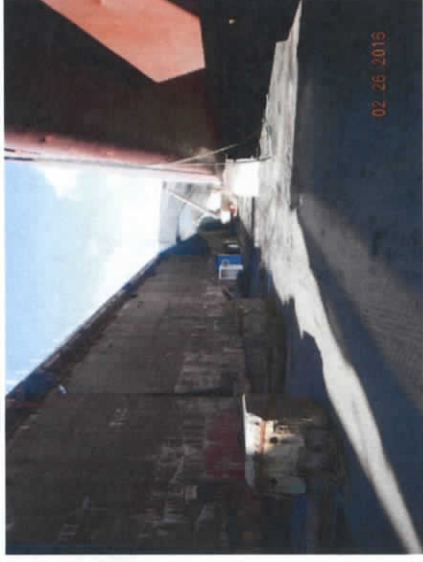
- iii. At the time of the inspection, EPA inspector McEathron observed spent grit, debris and waste in the north and south drainage channels and along the floor of Dry Dock 5 (see photographs DSCN6651.JPG – DSCN6657.JPG and DSCN6660.JPG – DSCN6664.JPG) and Dry Dock 6 (see photographs DSCN6694.JPG – DSCN6697.JPG and DSCN6699.JPG – DSCN6708.JPG).

DSCN6694.JPG	Close up of spent grit layer on floor of dry dock No. 6
DSCN6695.JPG	Drainage along south side with spent grit along drainage and broken metal grates
DSCN6696.JPG	Drainage along south side with spent grit along drainage and broken metal grates
DSCN6697.JPG	Drainage along south side with spent grit along drainage and broken metal grates
DSCN6698.JPG	Curtain
DSCN6699.JPG	Drainage along south side with spent grit along drainage and broken metal grates
DSCN6700.JPG	Drainage along south side with spent grit along drainage and broken metal grates
DSCN6701.JPG	Drainage along south side with spent grit along drainage and broken metal grates
DSCN6702.JPG	Drainage along south side with spent grit along drainage and broken metal grates
DSCN6703.JPG	Drainage along south side with spent grit along drainage and broken metal grates
DSCN6704.JPG	Drainage along north side filled with debris
DSCN6705.JPG	Drainage along north side filled with debris

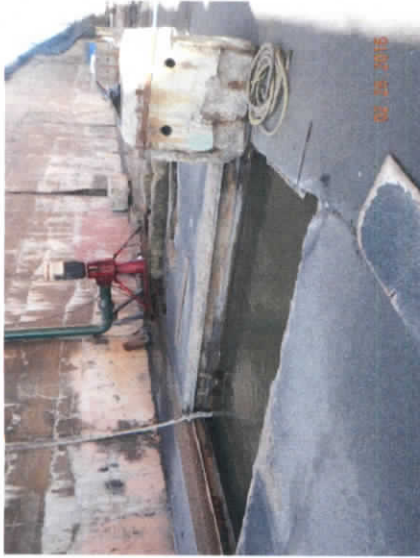
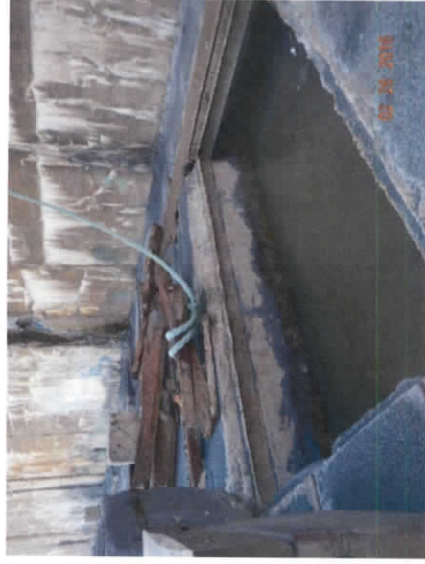
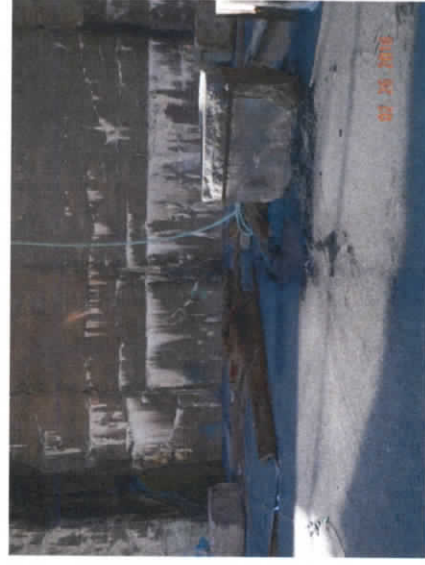
3. At the time of the inspection, EPA inspector McEathron observed corroded metal frames that were removed and exposed a hole in the floor of Dry Dock No. 6 (see photographs DSCN6696.JPG – DSCN6697.JPG and DSCN6699.JPG); and

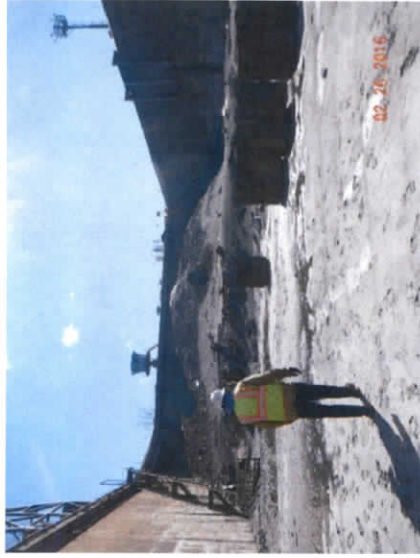
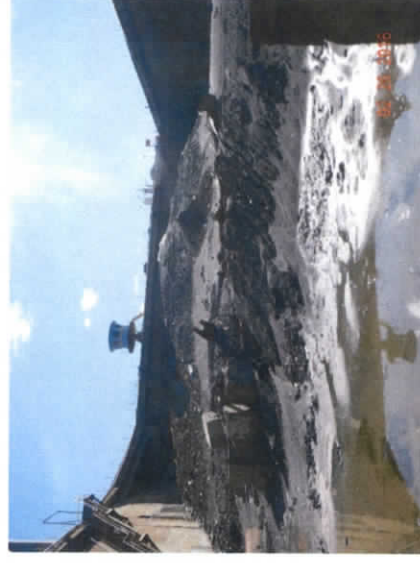
DSCN6706.JPG	Spent grit pile and thick layer of grit at east end of dry dock No. 6
DSCN6707.JPG	Spent grit pile and thick layer of grit at east end of dry dock No. 6
DSCN6708.JPG	Spent grit pile and thick layer of grit at east end of dry dock No. 6
DSCN6709.JPG	Spent grit pile and thick layer of grit at east end of dry dock No. 6
DSCN6710.JPG	Spent grit pile and thick layer of grit at east end of dry dock No. 6
DSCN6711.JPG	Spent grit pile and thick layer of grit at east end of dry dock No. 6
